Hazardous Materials Survey

0000 Shelbourne Street Victoria, B.C.
June 14, 2016

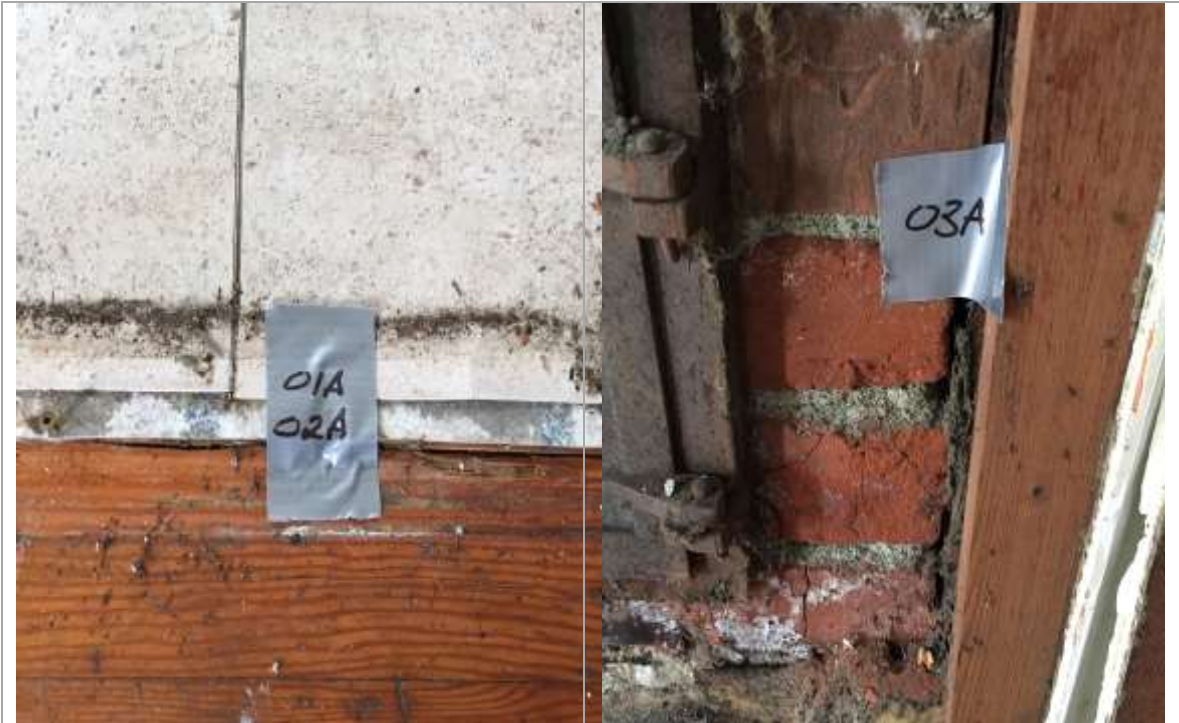
01A/02A-Kitchen Flooring

03A-Chimney mortar

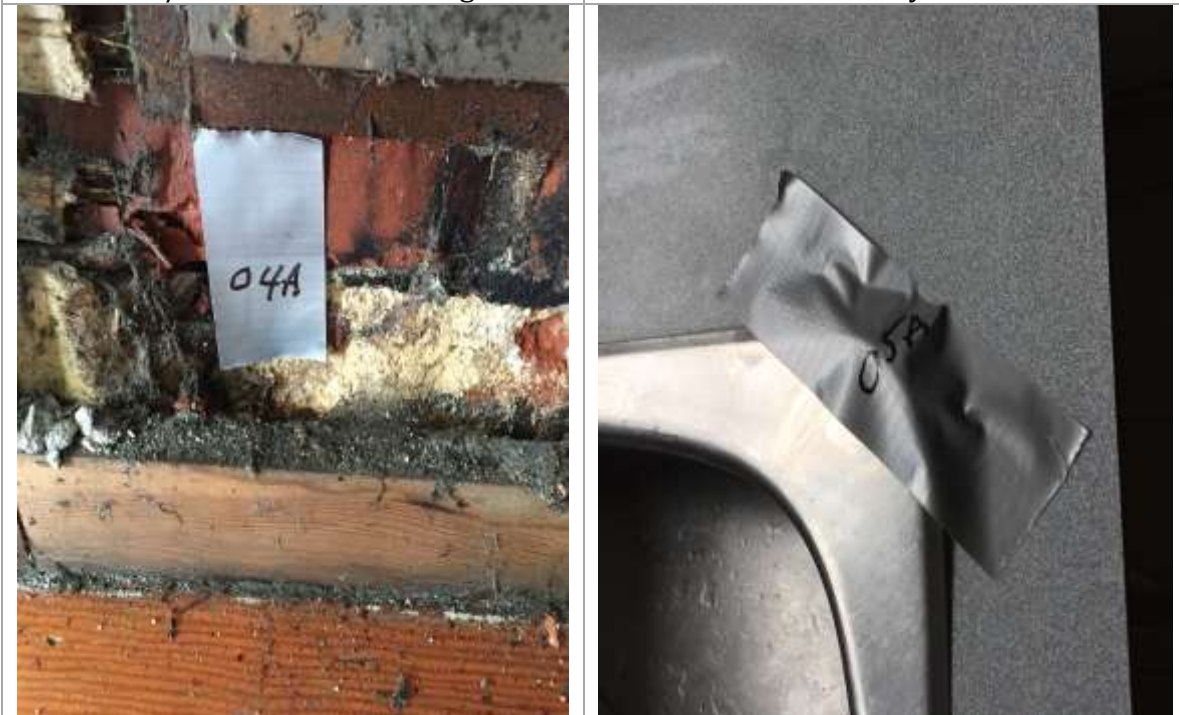
Hazardous Material	Type and Location
Asbestos*	<p>3% Chrysotile – Under sink mastic</p> <p>2% Chrysotile – Bottom layer hallway flooring</p> <p>2% Chrysotile – Bottom layer bedroom flooring</p> <p>3% Chrysotile – Top layer bedroom 2 flooring</p> <p>5% Chrysotile – Roof vent mastic</p>
Lead	<p>3.9% by weight – White living room window sill</p> <p>0.037% by weight – White living room wall</p> <p>0.26% by weight – White exterior window</p>

04A-Masonry Compound

05A-Undersink Mastic
(3% Chrysotile)

1. Have a qualified abatement contractor remove and dispose of all asbestos containing vinyl flooring throughout the home.
2. A qualified abatement contractor must remove and dispose of all asbestos containing mastic (roof vents, chimney and under sink). Do not disturb without following proper work procedures prepared by a qualified person.

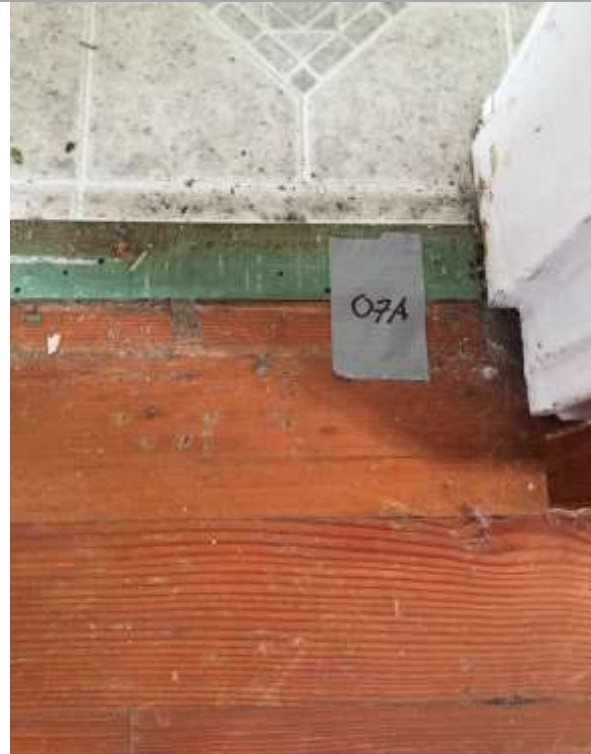
07A-Bottom Layer Flooring hallway
(2% Chrysotile)

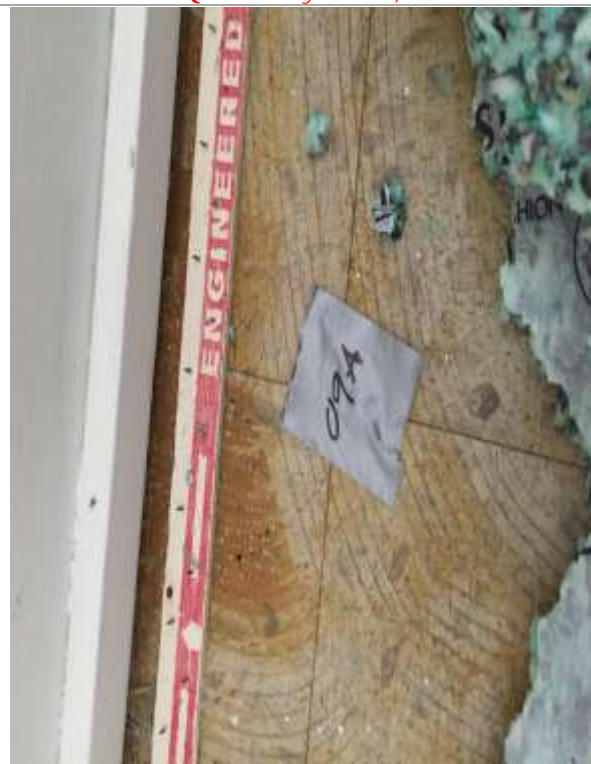
09A-Bottom Layer Flooring Bedroom
(2% Chrysotile)

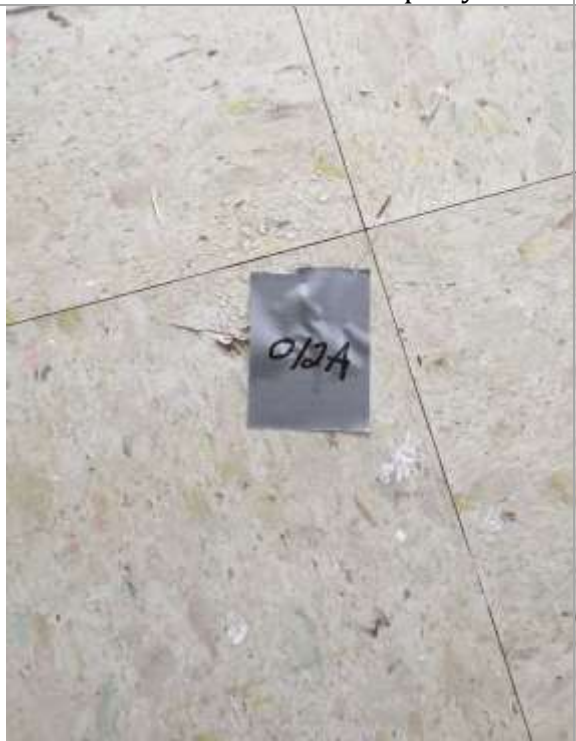
012A-Bedroom 2 Top Layer Flooring
(3% Chrysotile)

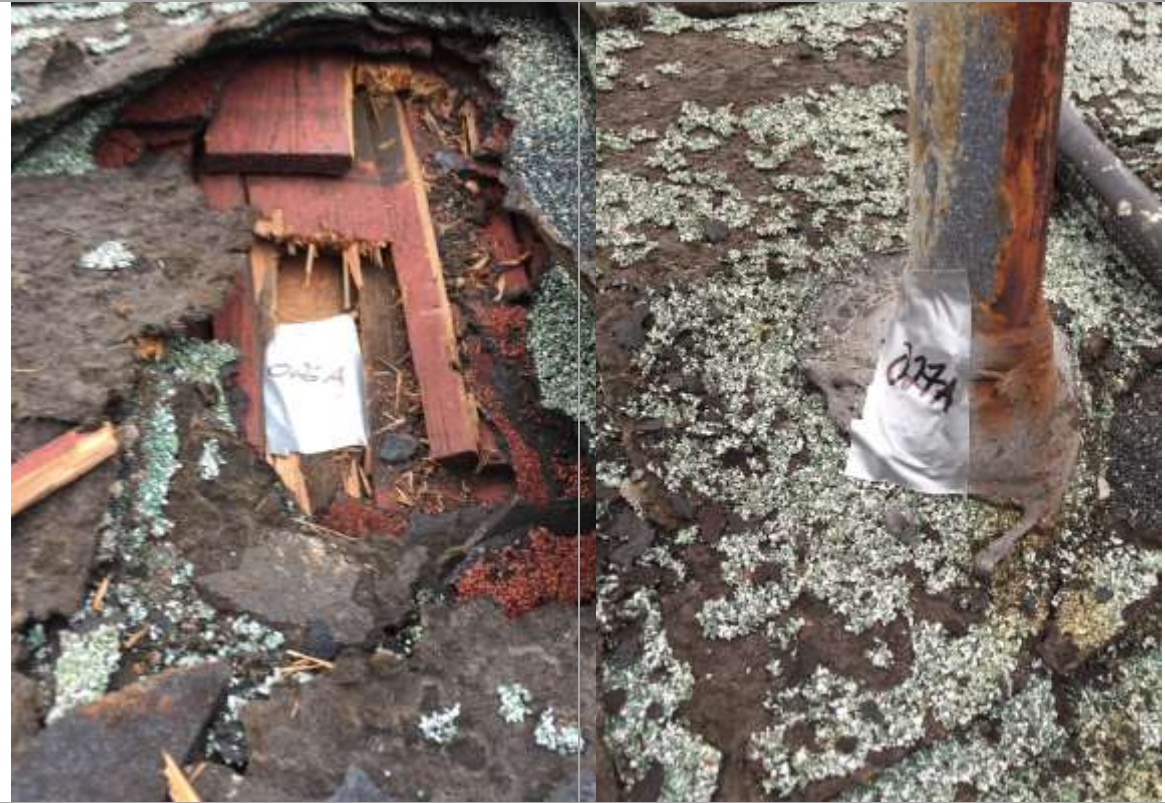
026A-Roof Shingle (3 Layers)

027A-Roof Vent Mastic
(5% Chrysotile)

027A	roof vent mastic	5% Chrysotile		95% Other	Black Non Fibrous Homogeneous
1610982PLM_27					Dissolved

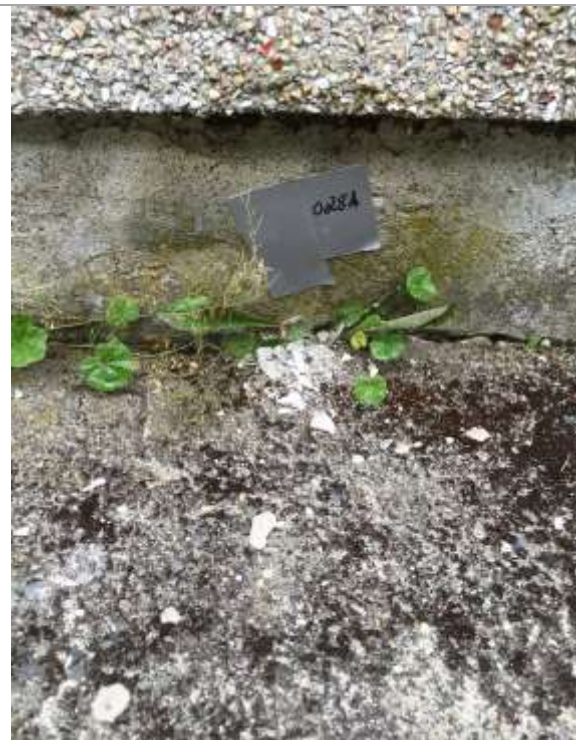
028A-Foundation Wall Mortar

Sample ID	Description	Asbestos	Fibrous Components	Non-Fibrous Components	Attributes
Lab Sample ID	Lab Notes				Treatment
028A	foundation wall mortar	None Detected		100% Other	Gray Non Fibrous Homogeneous
1610982PLM_28					Dissolved
